## Vision Enhancement for Fire Fighters

J. B. HOOVER, F. K. LEPPLE, AND J. T. LEONARD

*Navy Technology Center for Safety and Survivability  
Chemistry Division*

May 30, 1989

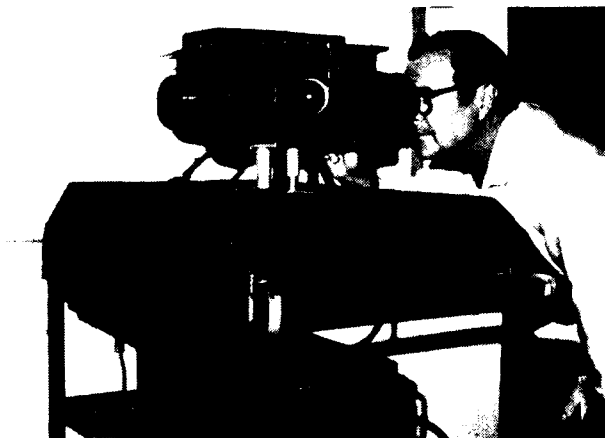
Fig. 4 — The AN/SAR-6 (a) and AN/TAS-2 (b) imagers were early military thermal imaging systems

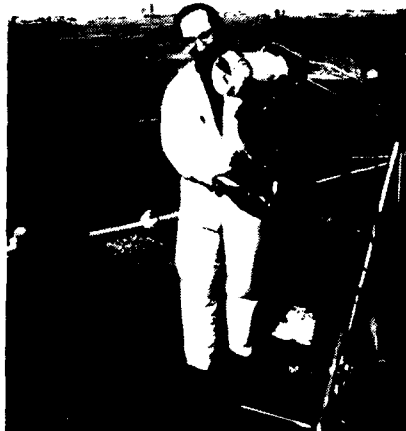
Fig. 17 — The EEV P4428 thermal imager, which replaced the Model P4228 in 1984, is shown here during testing aboard the USCG test ship *A. E. Watts*.

The Model P4428 replaced the P4228 in 1984. Figure 17 shows the new model, and Table 4 gives its specifications. From the operational standpoint, the most significant change that occurred was the packaging of the system in two modules, imager and power supply, instead of all in one unit. By removing the batteries and some of the power supply electronics, the weight of the imager module was reduced by about 1 kg (2.2 lb), even though the total weight of the system was almost unchanged. Equally important was the removal of the voltage regulator (which is a significant heat source), allowing the imager's diameter to be reduced from 24 to 16.5 cm (9.5 to 6.5 in.) without affecting the imager's thermal protection. The power supply module was attached to a harness, permitting it to be suspended from the neck rather than carried by the hand. Reducing the size and weight of the handcarried imager module made it feasible to operate the system with only one hand. A pistol grip was attached to the P4428 for this purpose. The other major change was an improvement of the image processing electronics that removed most of the chop-mode flicker through a digital subtraction process. The result was a significant improvement in image quality as compared to the Model P4228.
